Manhole Inspection Summary

Manhole # S35II_015MH

Location Address: **201 LAFAYETTE AVE**

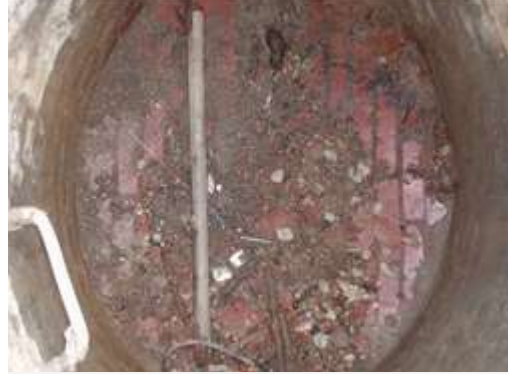
Top View

Channel debris.

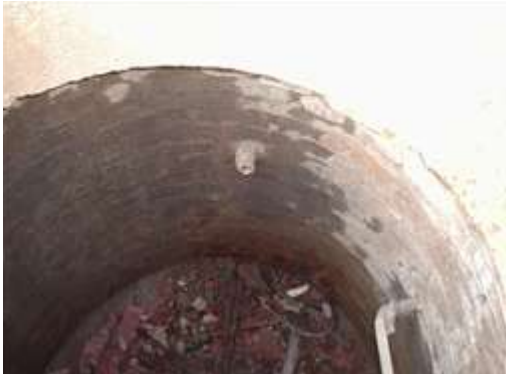
Defect

Frame leaks. Adjustment and Barrel infiltration - other side.

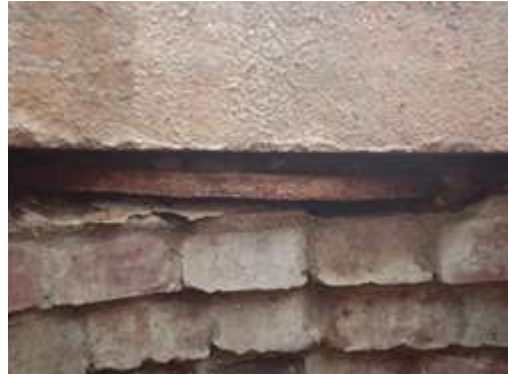
Defect

Frame leaks. Adjustment deterioration and infiltration.

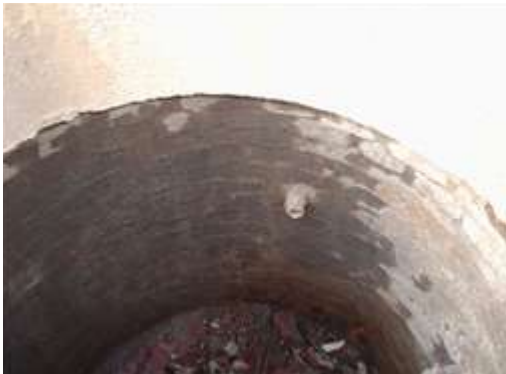
Defect

Frame leaks. Adjustment and Barrel infiltration. Valve.

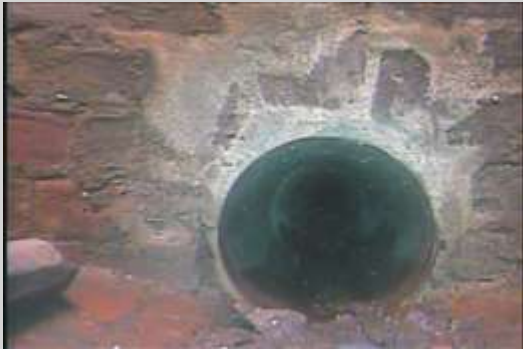
8 in. Circular Gravity Sewer
Pipe Out @ 12 O'Clock

Deposits: ☐ None ☒ **Mud** ☐ Sludge ☒ **Debris** ☐ Grease

Silt Depth: **0.5** (in.) Deposits Extent: **Light**
